Coal Combustion Waste Impoundment

Round 5 - Dam Assessment Report

Winyah Generating Station (Site #004)

Santee Cooper

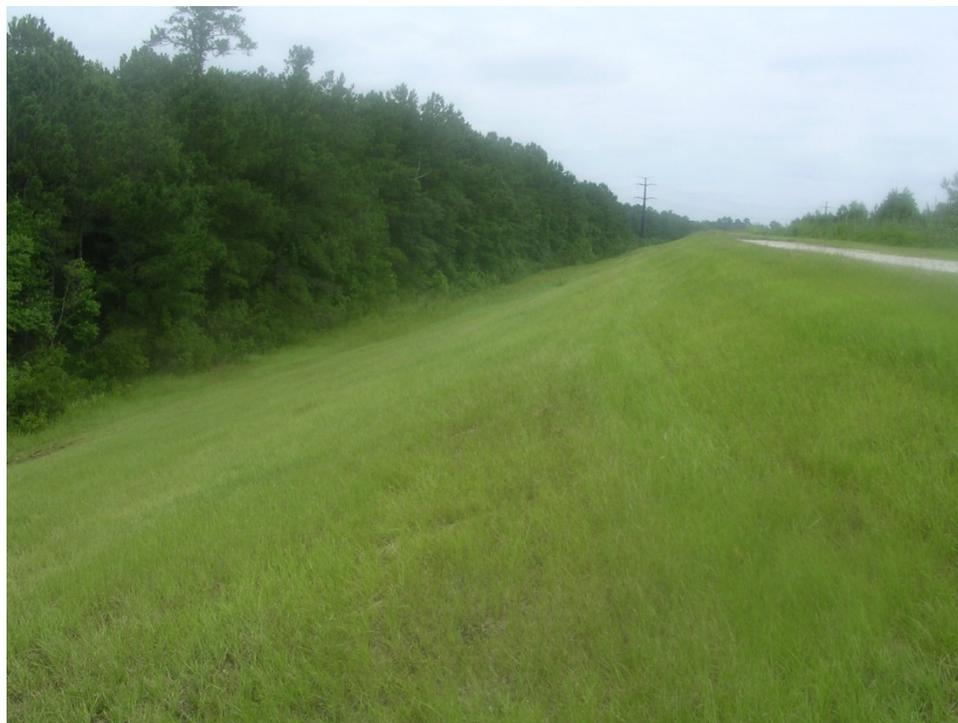
Photo BW-11: Outside Slope Perimeter Dike West Side of West Ash Pond – Viewed North.

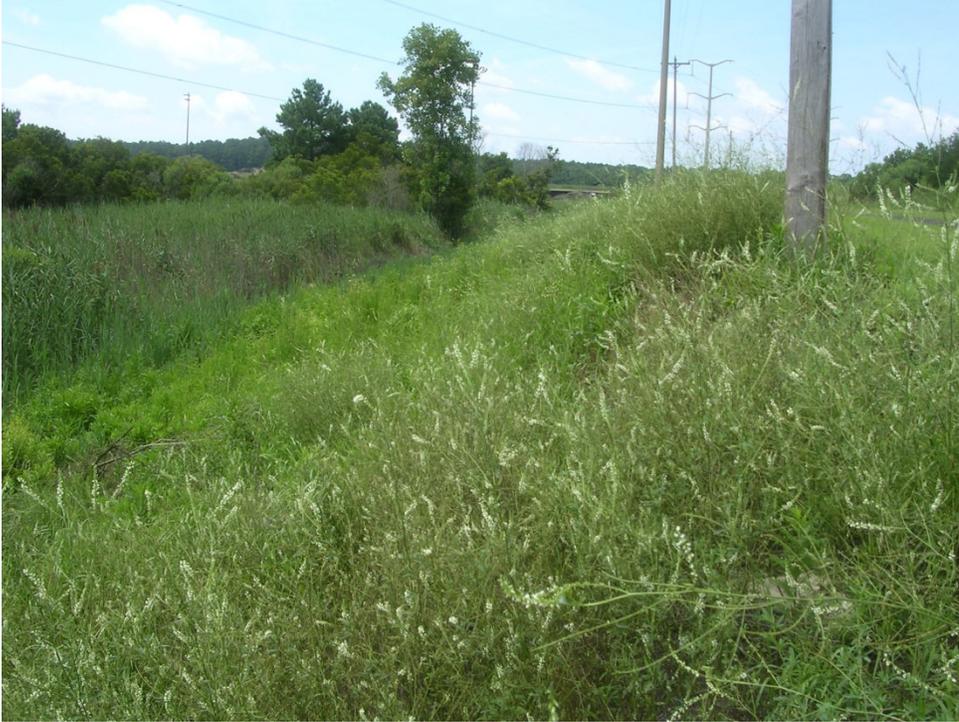
Photo BW-12: Outside Slope of Perimeter Dike along East Side of West Ash Pond– Viewed South.

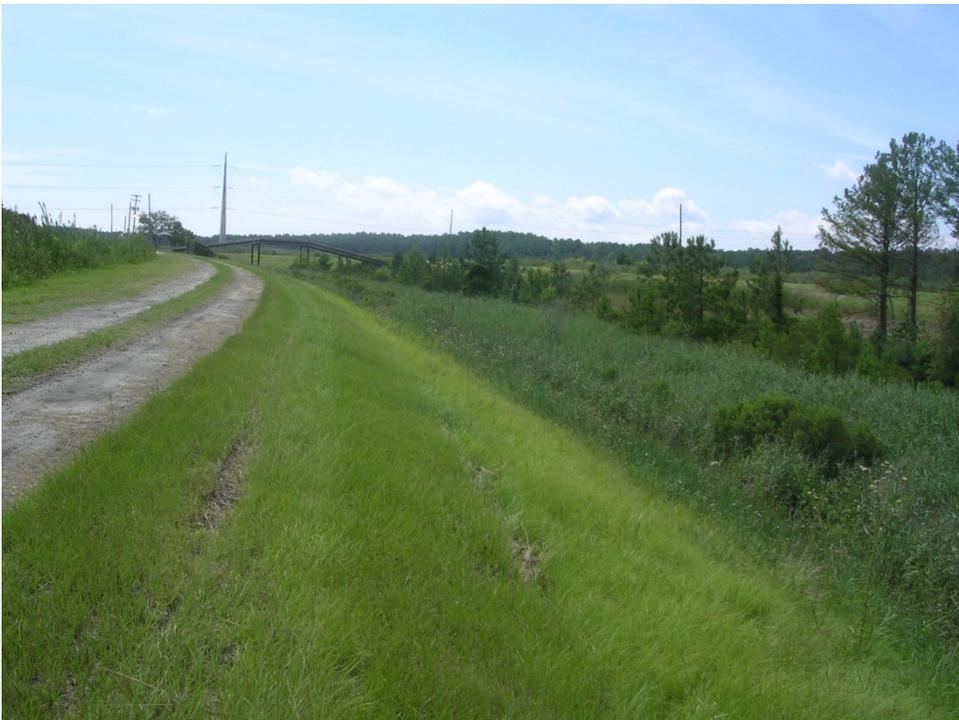
Photo BW-13: Outside Slope of Perimeter Dike near Southeast Corner – Viewed Southeast.

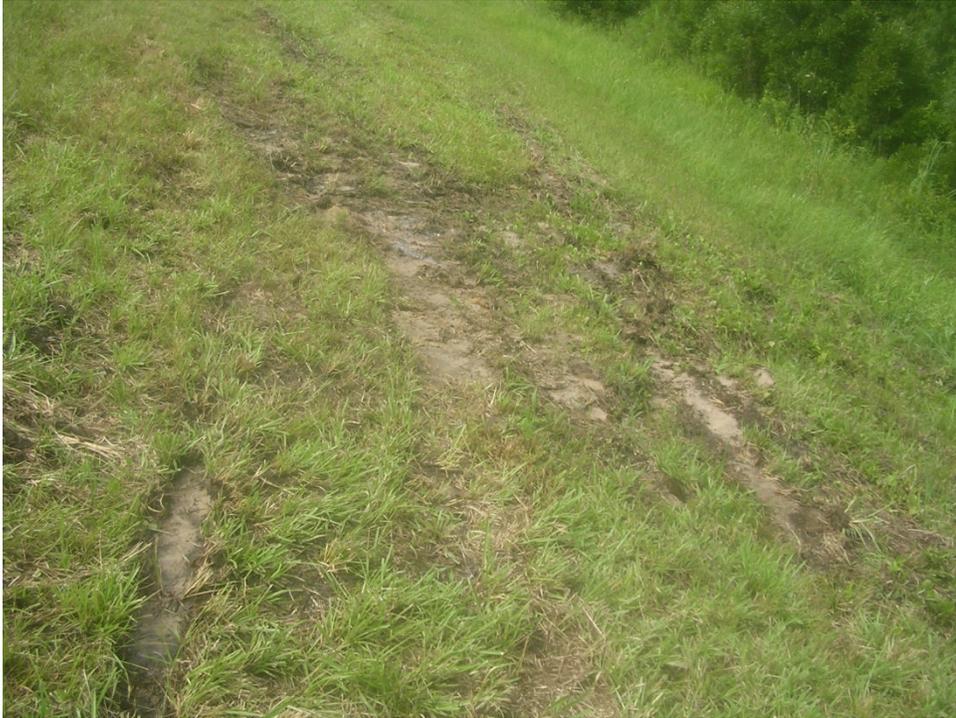
Photo BW-14: Wet Soil Area Outside Toe of Embankment Perimeter Dike West Side of West Ash Pond.

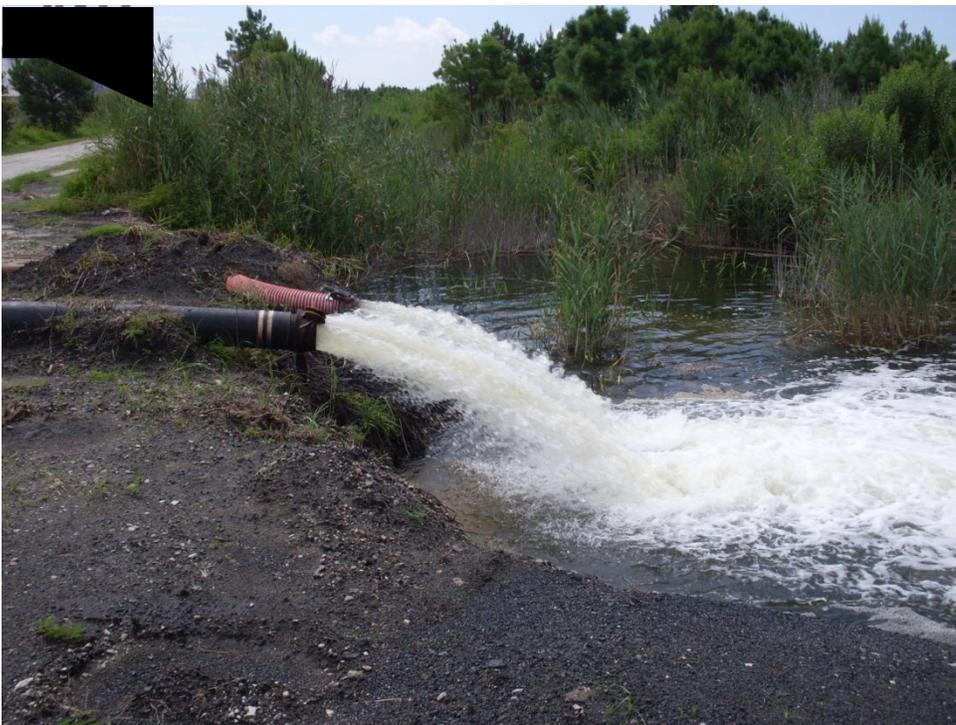
Photo BW-15: Inside View of West Ash Pond Where Unit 3 & 4 Slurry Pond Discharge into Pond at North End of West Perimeter Dike.

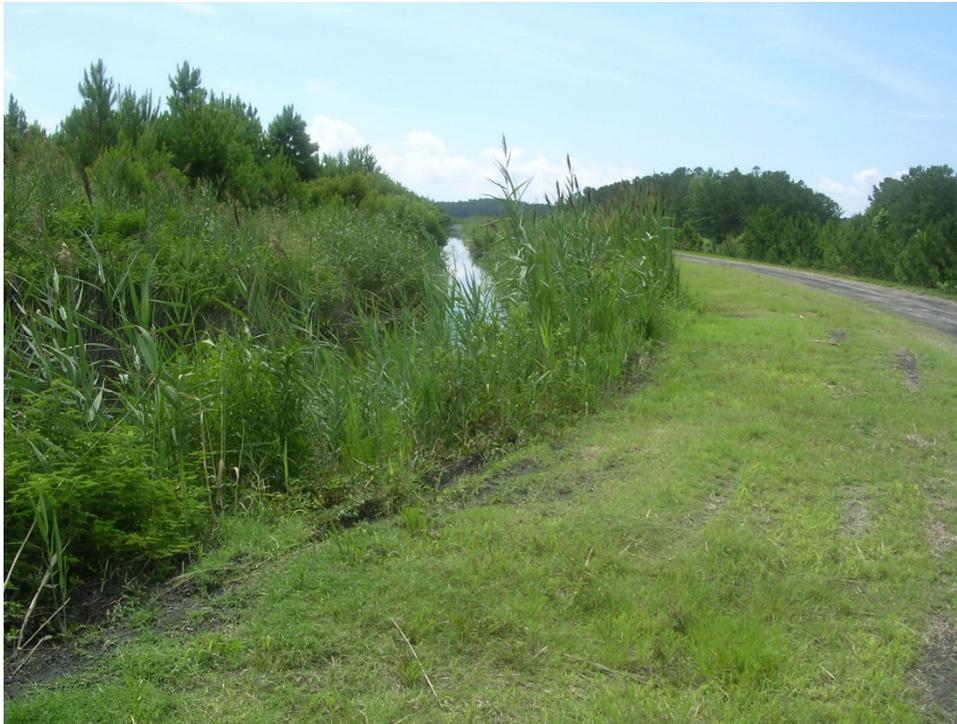
Photo BW-16: Inside Slope of Perimeter Dike at Bend to at Southwest Side of West Ash Pond – Viewed Southeast.

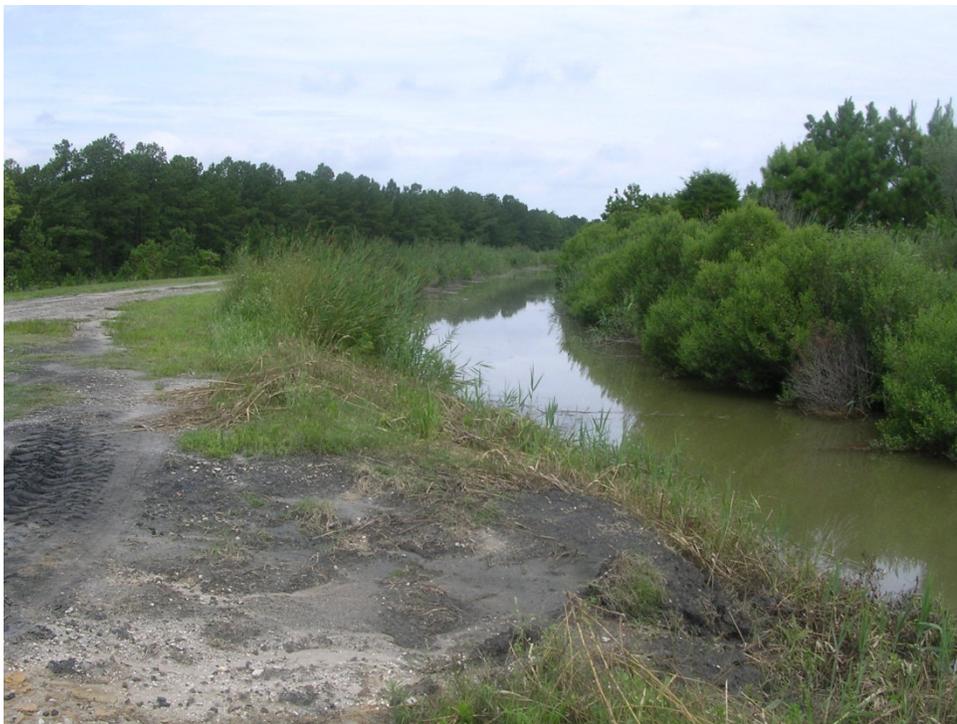
Photo BW-17: Inside Slope of Perimeter Dike along Southeast Corner of West Ash Pond – Viewed Northwest.

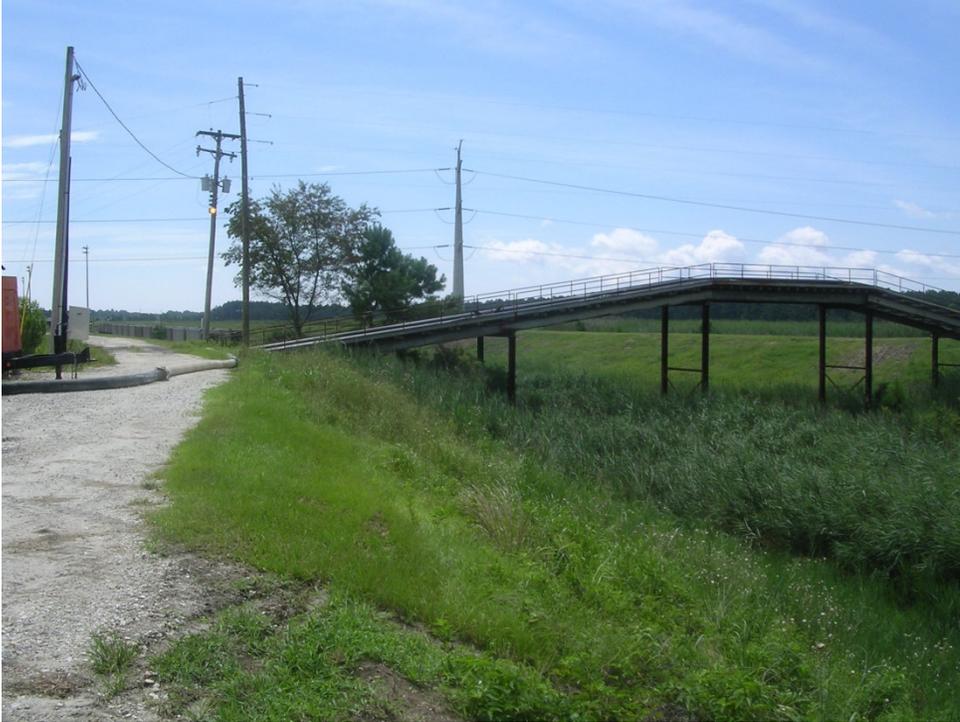
Photo BW-18: View of Pump Discharge Lines on Bridge from West Ash Pond Southeast Corner to South Ash Pond – Viewed East.

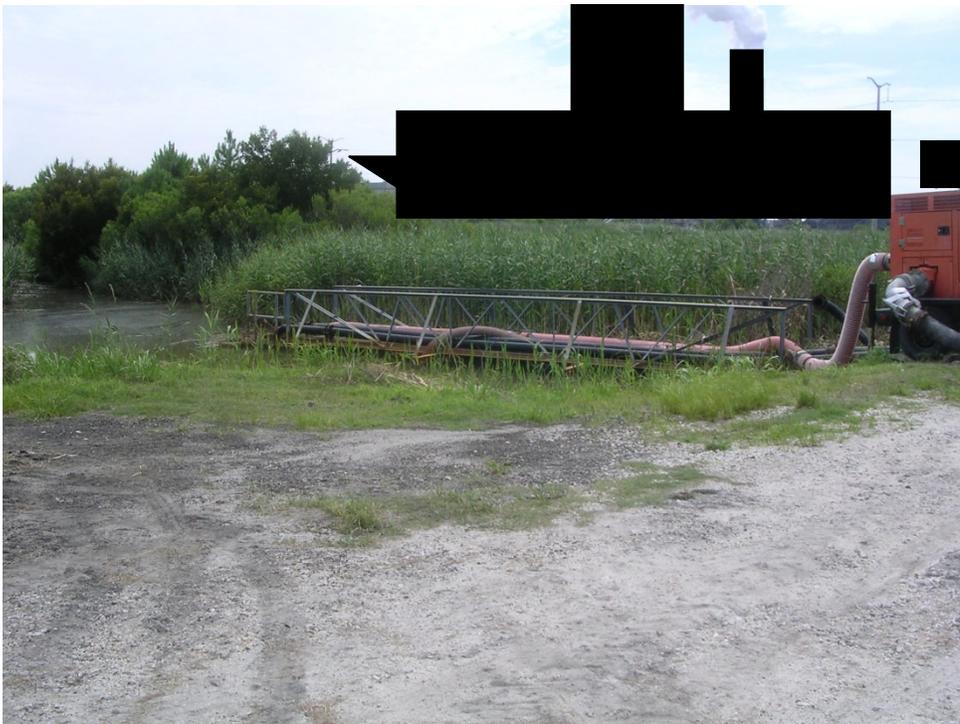
Photo BW-19: Existing Decant Tower in Southeast Corner of West Ash Basin (Note Suction Lines for Pumping Water from Decant Tower to South Ash Basin).

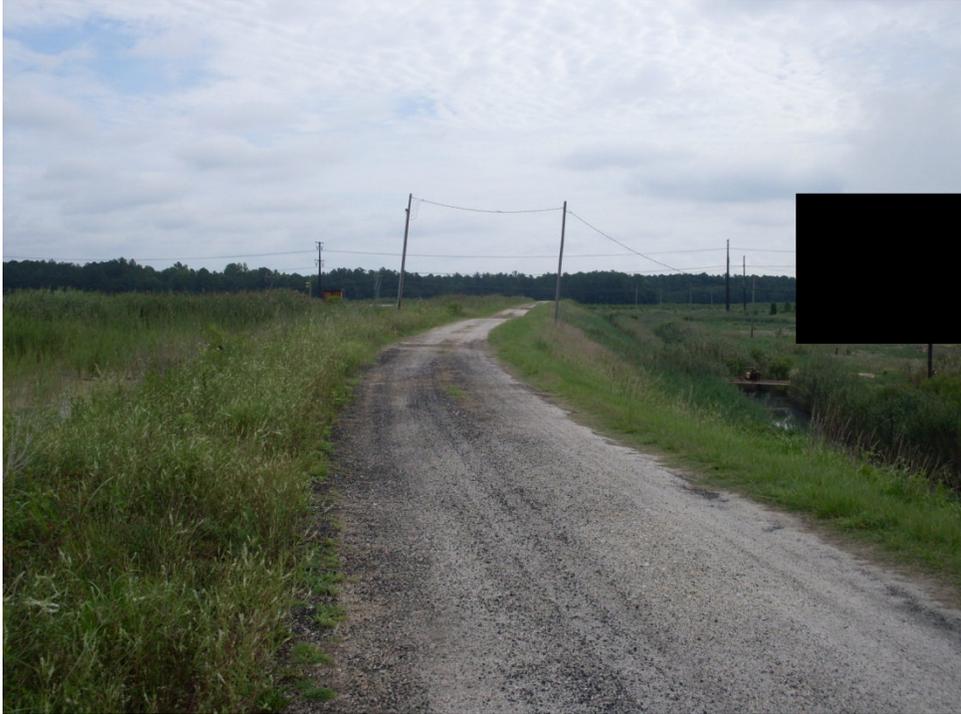
Photo B3-1: Crest of Perimeter Dike Southeast Side of Unit 3 & 4 Slurry Pond
- Viewed North.

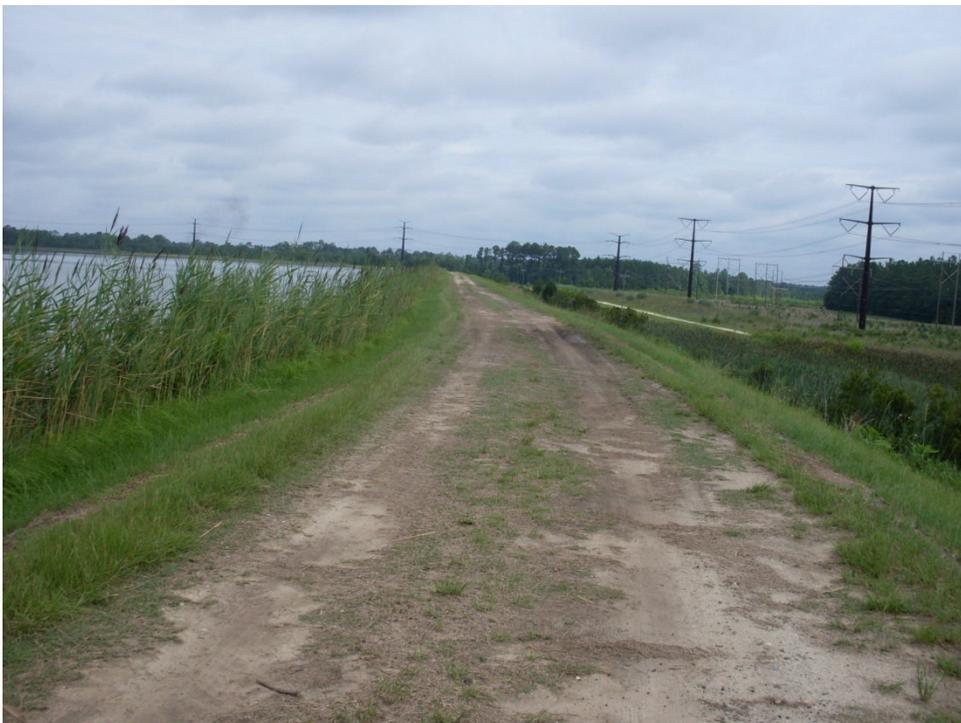
Photo B3-2: Crest of Perimeter Dike Northeast Side of Unit 3 & 4 Slurry Pond
- Viewed Northwest.

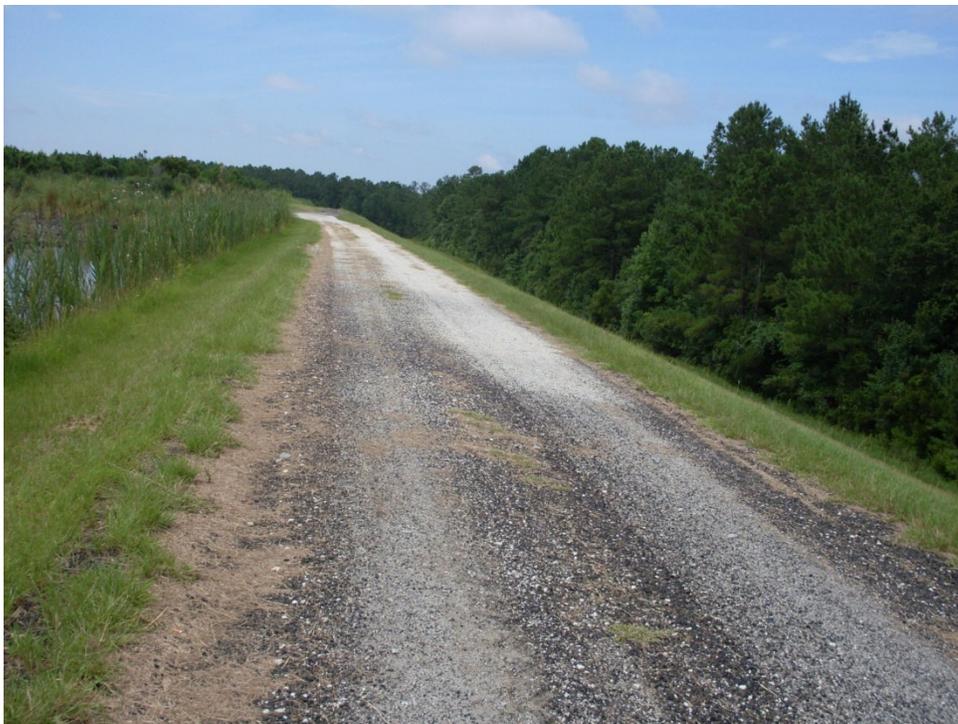
Photo B3-3: Crest of Perimeter Dike West Side of Unit 3 & 4 Slurry Pond – Viewed South.

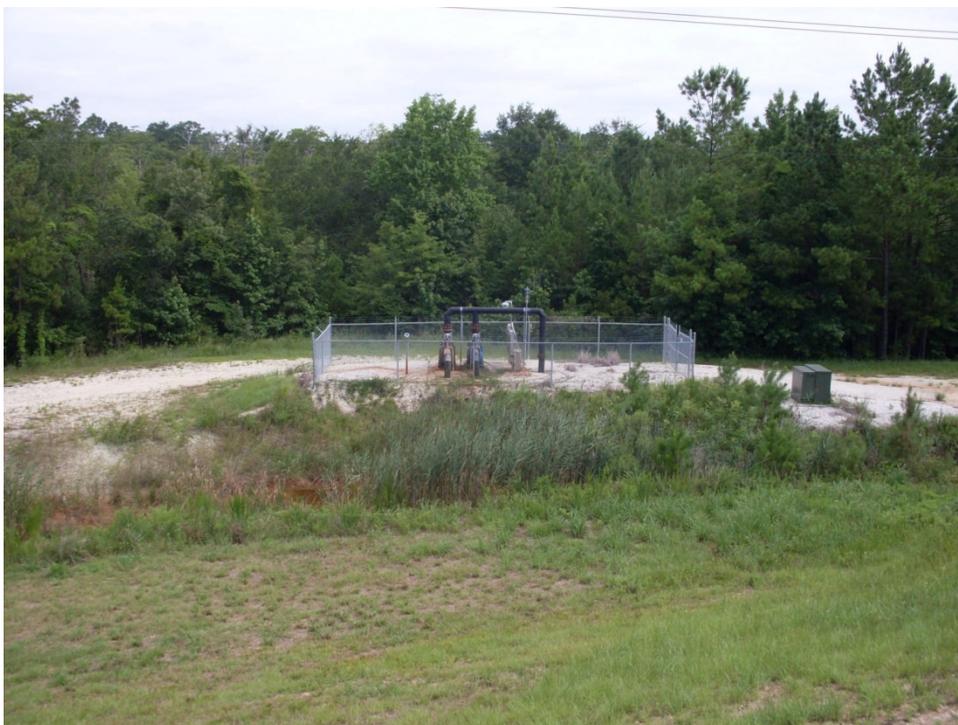
Photo B3-4: Pump Station at Outside Toe of Northwest Side of Unit 3 & 4 Slurry Pond (For Pumping Water from Toe Ditch through Buried Line into Unit 3 & 4 Slurry Pond).

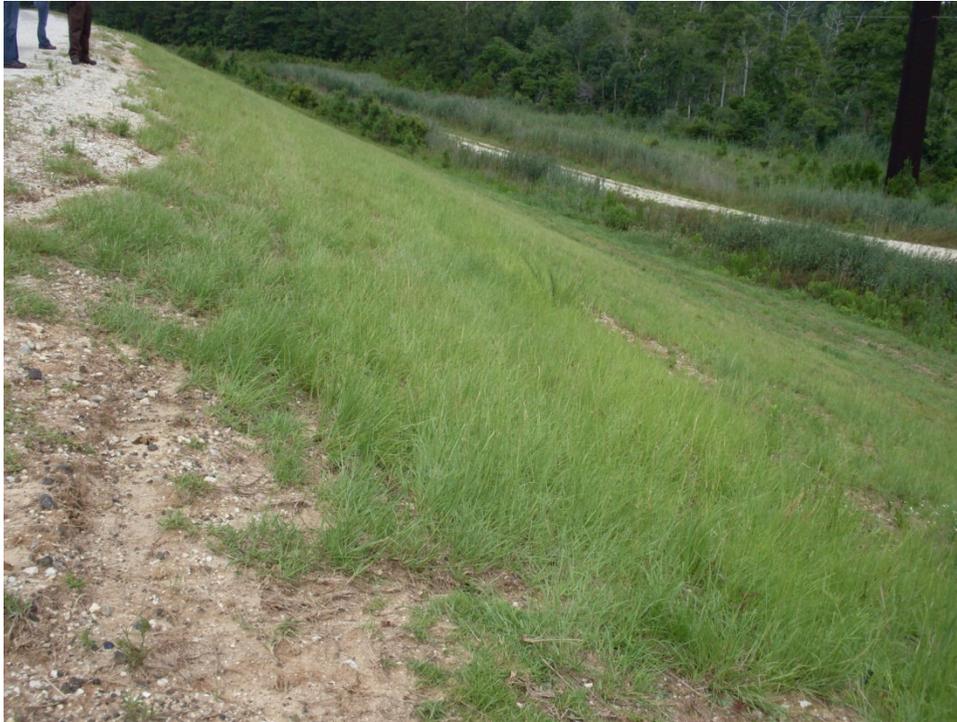
Photo B3-5: Outside Slope of Perimeter Dike of Northwest Side of Unit 3 & 4 Slurry Pond at Repaired Location.

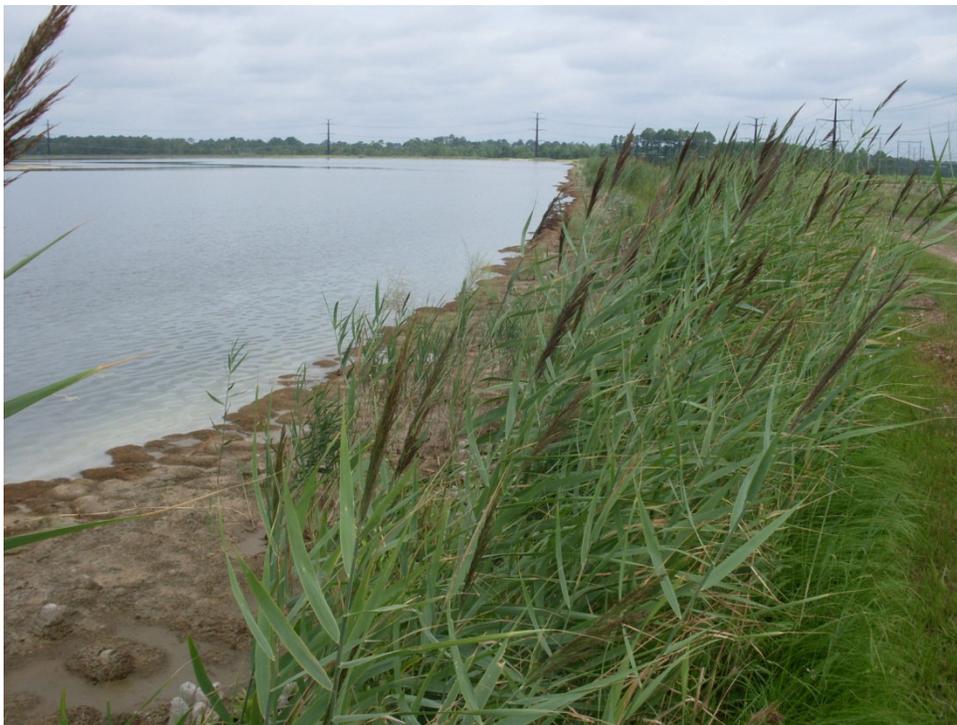
Photo B3-6: Inside Slope of Perimeter Dike at Northeast side of Unit 3 & 4 Slurry Pond – Viewed Northwest.

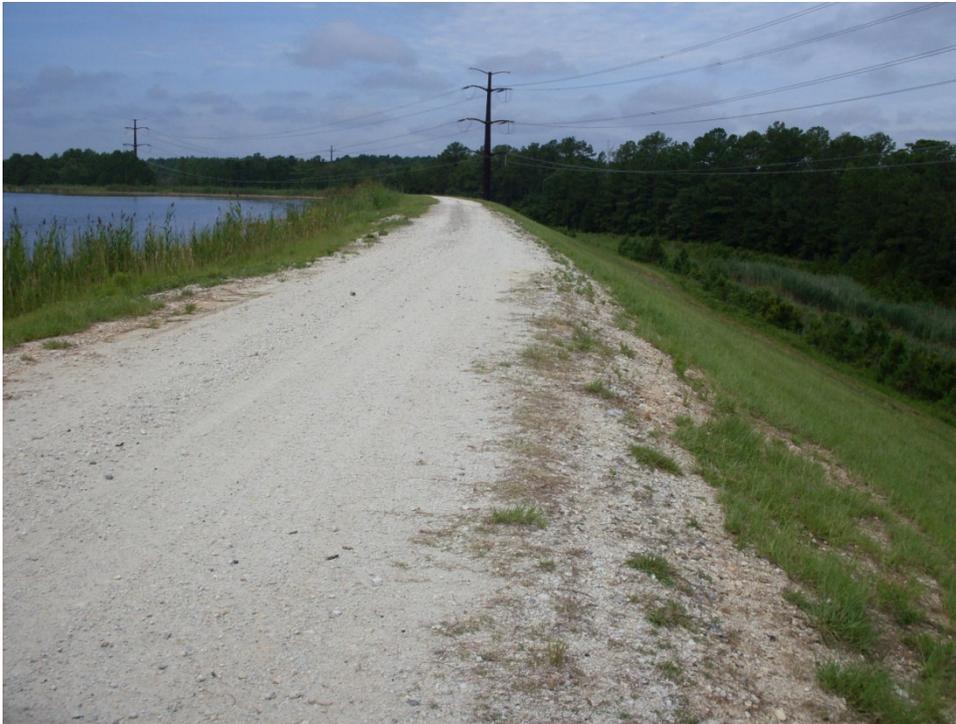
Photo B3-7: Crest of Perimeter Dike at Northwest side of Unit 3 & 4 Slurry Pond at Repaired Location – Viewed East.

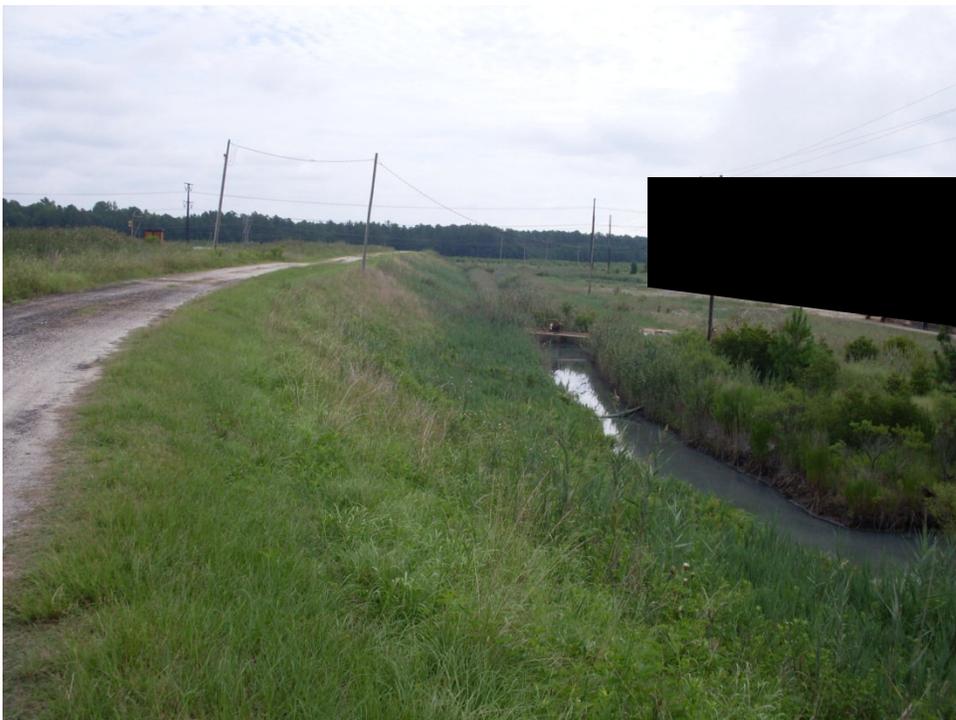
Photo B3-8: Outside Slope of Perimeter Dike Southeast Side of Unit 3 & 4 Slurry Pond – Viewed North.

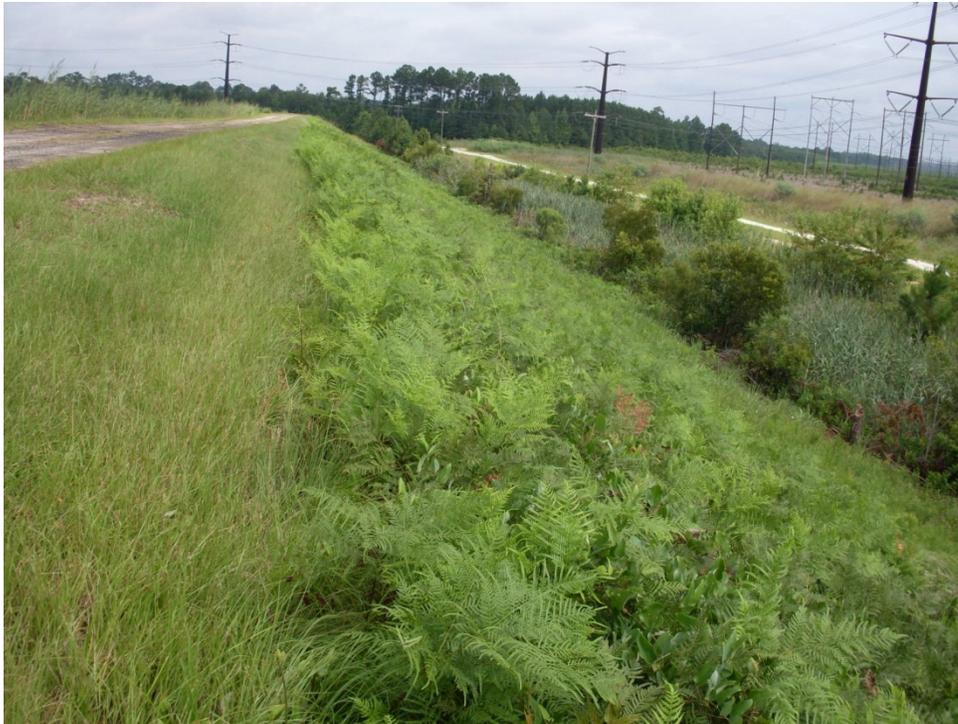
Photo B3-9: Outside Slope of Perimeter dike Northeast Side of Unit 3 & 4 Slurry Pond – Viewed Northwest.

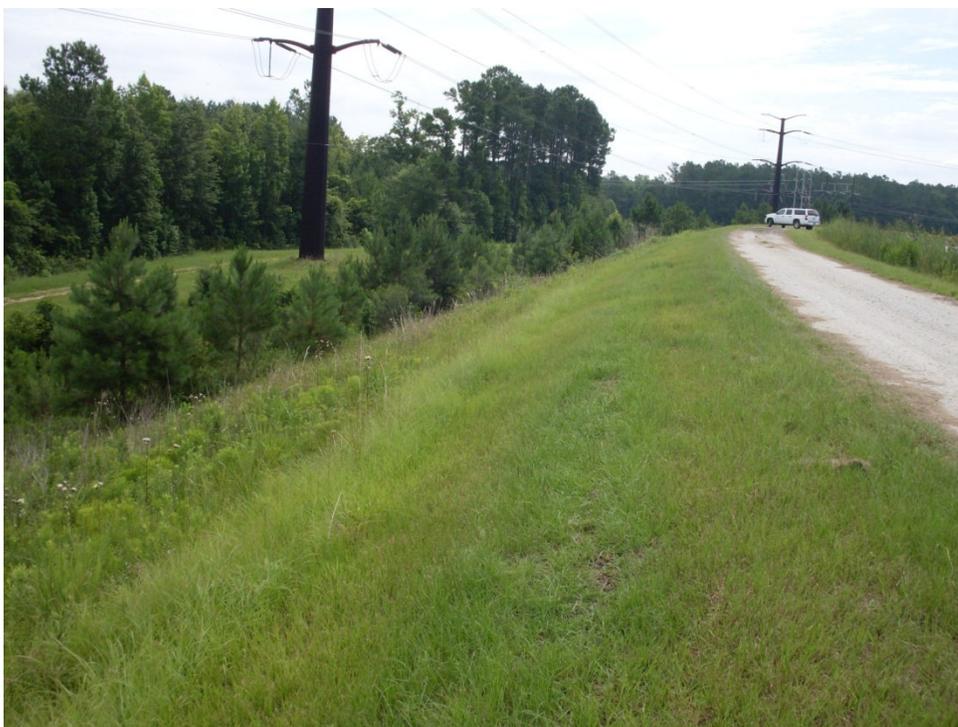
Photo B3-10: Outside Slope of Perimeter Dike Northwest Side of Unit 3 & 4 Slurry Pond – Viewed East.

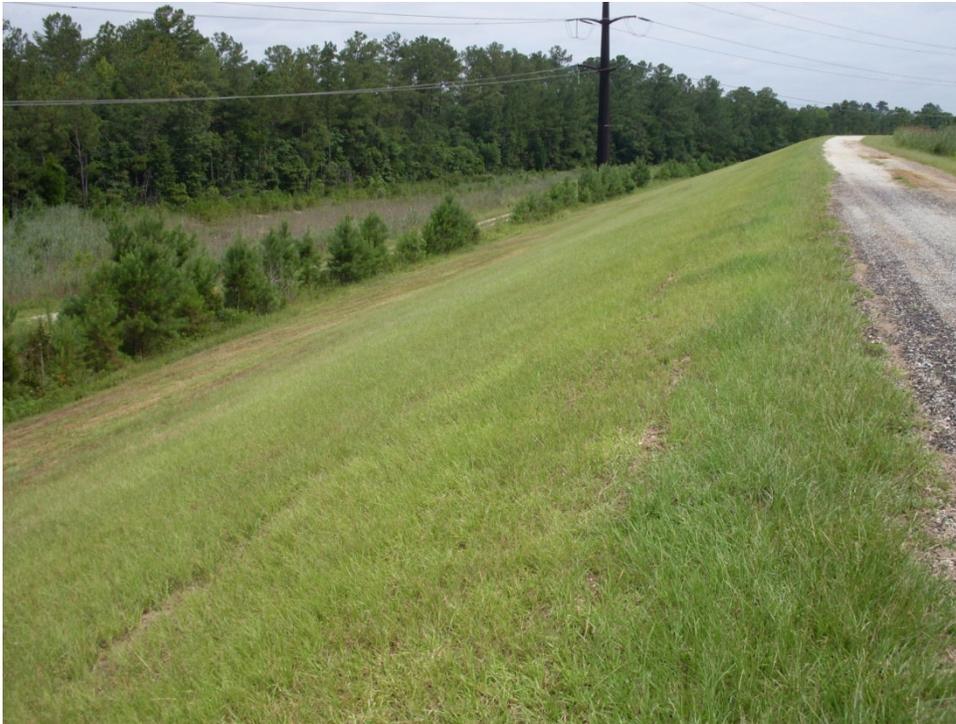
Photo B3-11: Outside Slope of Perimeter Dike West Side of Unit 3 & 4 Slurry Pond – Viewed North.

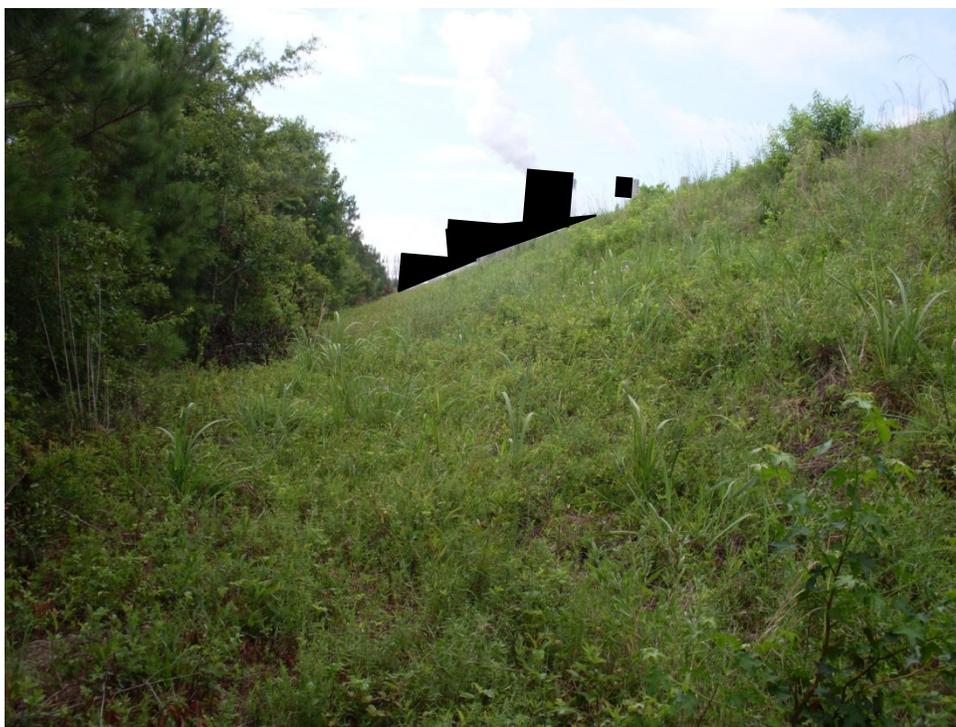
Photo B3-12: Outside Toe of Perimeter Dike Northeast Side of Unit 3 & 4 Slurry Pond – Viewed Southeast.

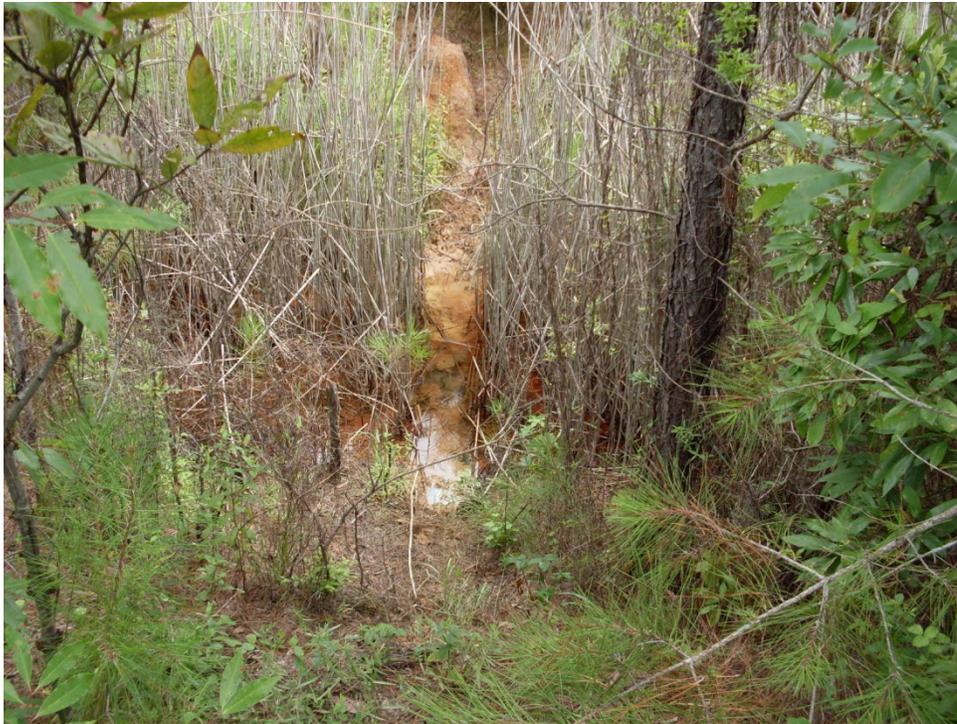
Photo B3-13: Outside Toe of Perimeter Dike Northeast Side of Unit 3 & 4 Slurry Pond (Note Overgrown Toe Ditch).

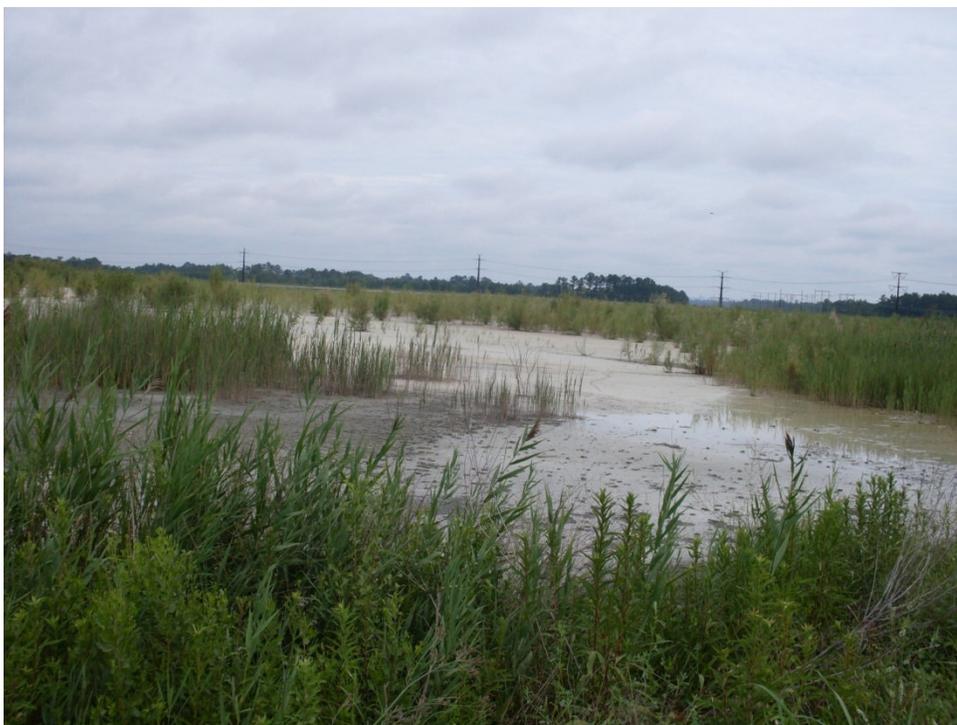
Photo B3-14: Unit 3 & 4 Slurry Pond Surface Inside Perimeter Dike on Southeast Side – Viewed Northwest.

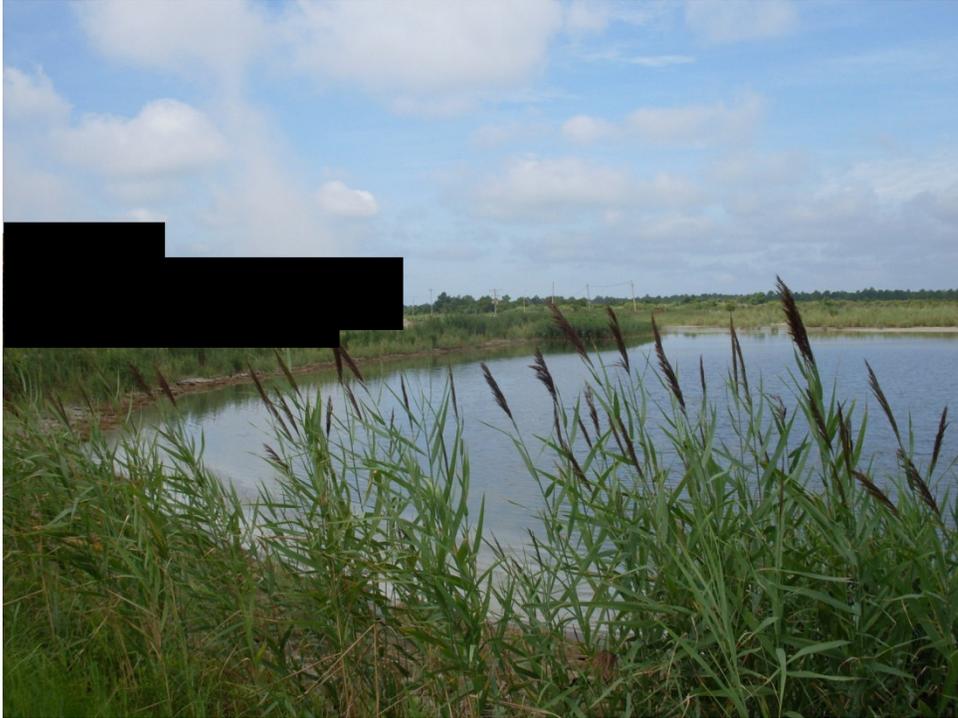
Photo B3-15: Inside Slope of Perimeter Dike Southeast Side of Unit 3 & 4 Slurry Pond - Viewed South.

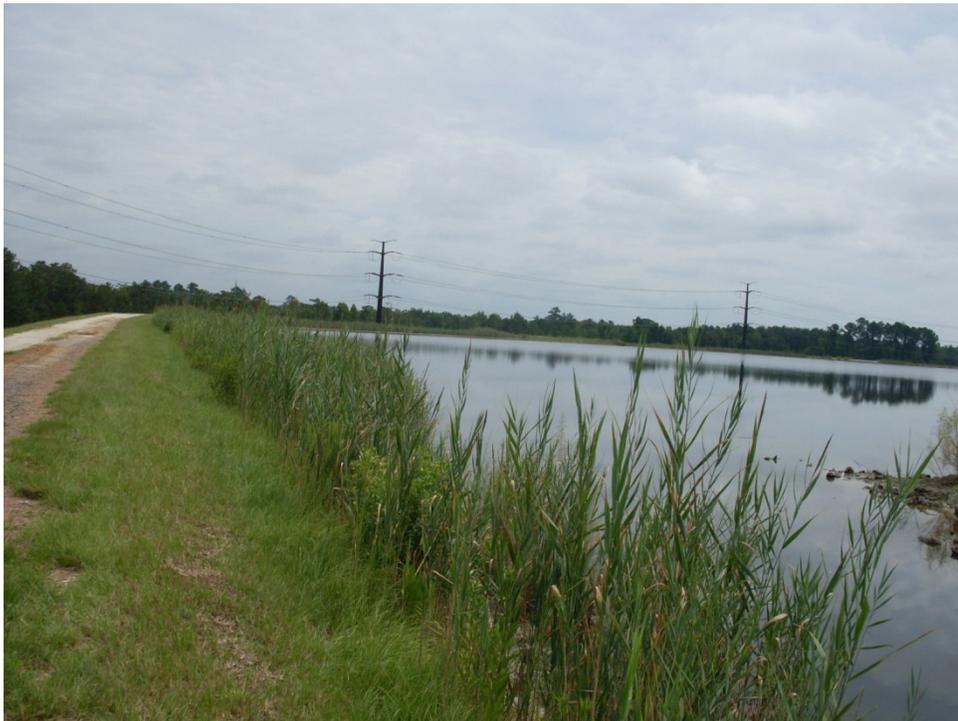
Photo B3-16: Inside Slope of Perimeter Dike West Side of Unit 3 & 4 Slurry Pond – Viewed North.

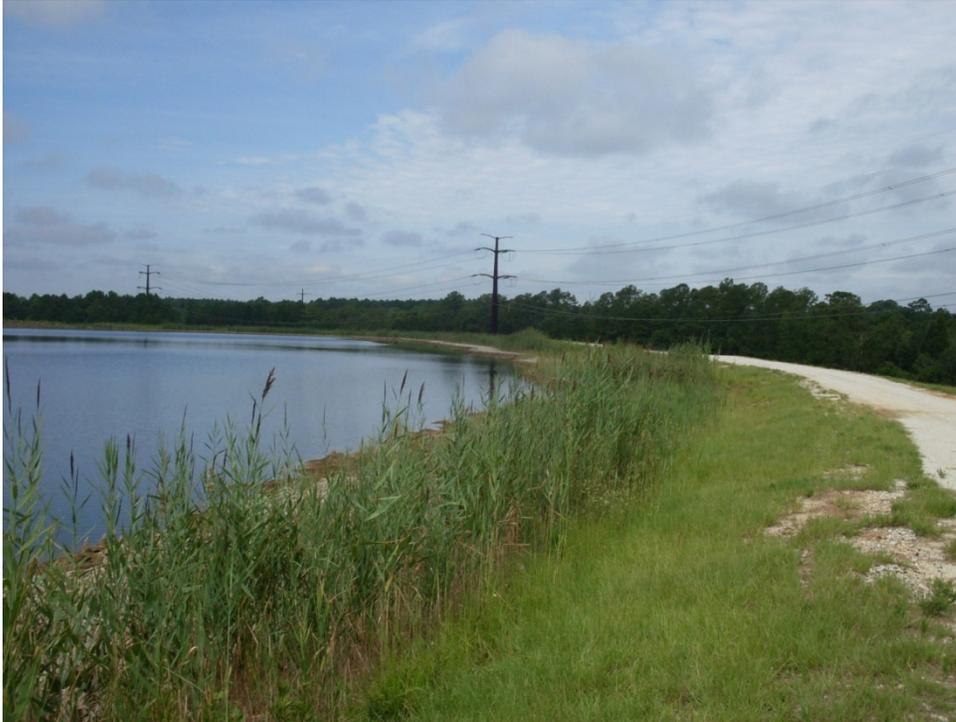
Photo B3-17: Inside Slope of Perimeter Dike at Northwest Side of Unit 3 & 4 Slurry Pond – Viewed West.

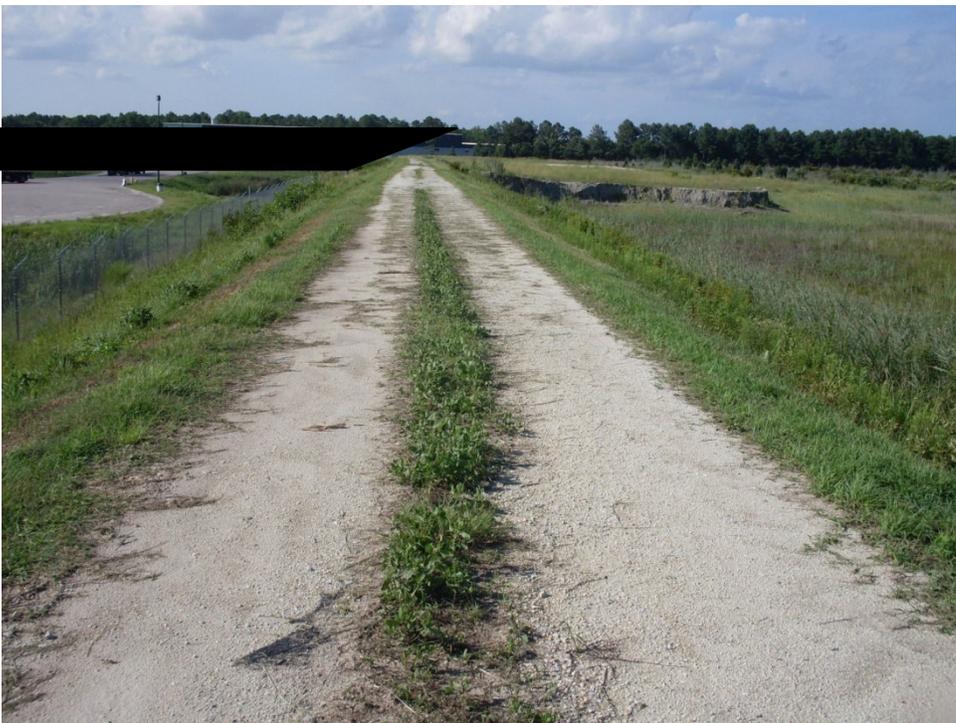
Photo B2-1: Crest of Perimeter Dike West Side of Unit 2 Slurry Pond– Viewed North.

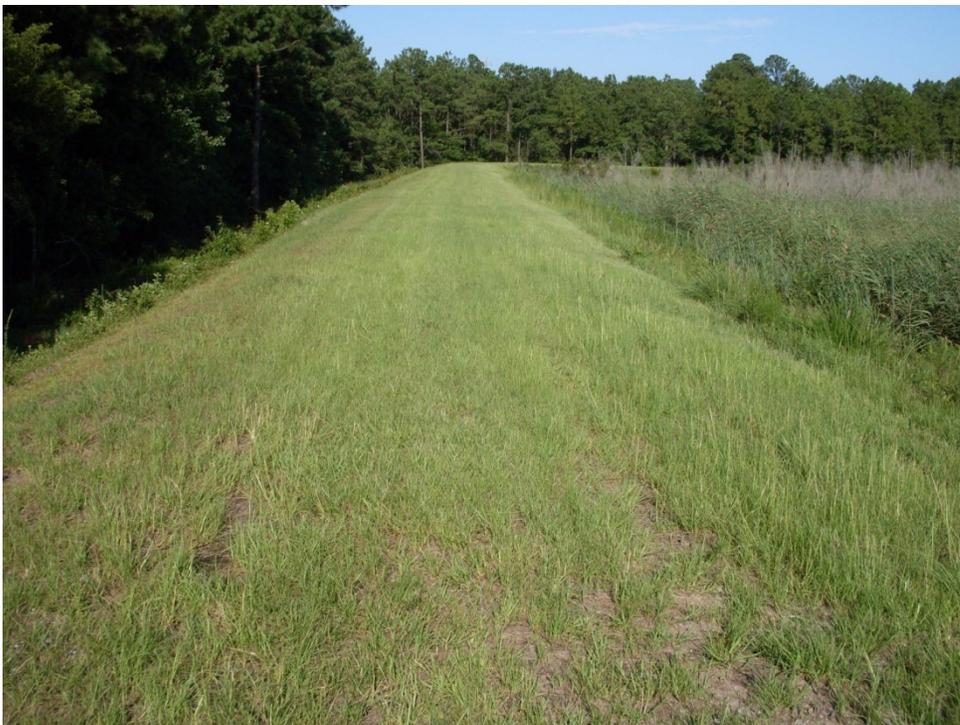
Photo B2-2: Crest of Perimeter Dike North Side of Unit 2 Slurry Pond East of Cross Dike– Viewed East.

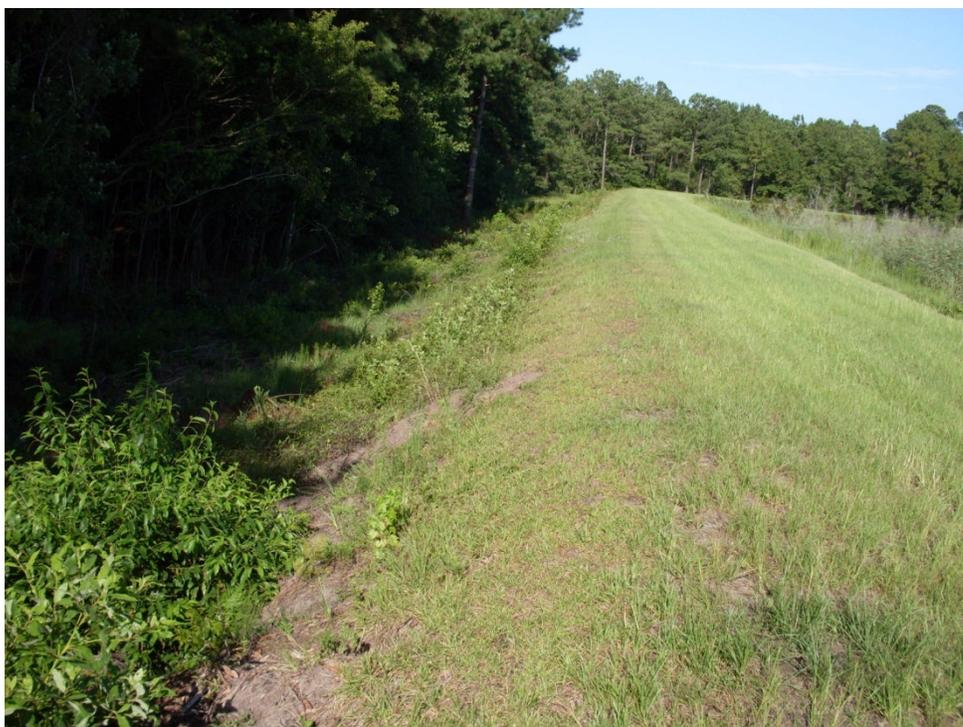
Photo B2-3: Crest of Perimeter Dike North Side of Unit 2 Slurry Pond East of Cross Dike – Viewed East.

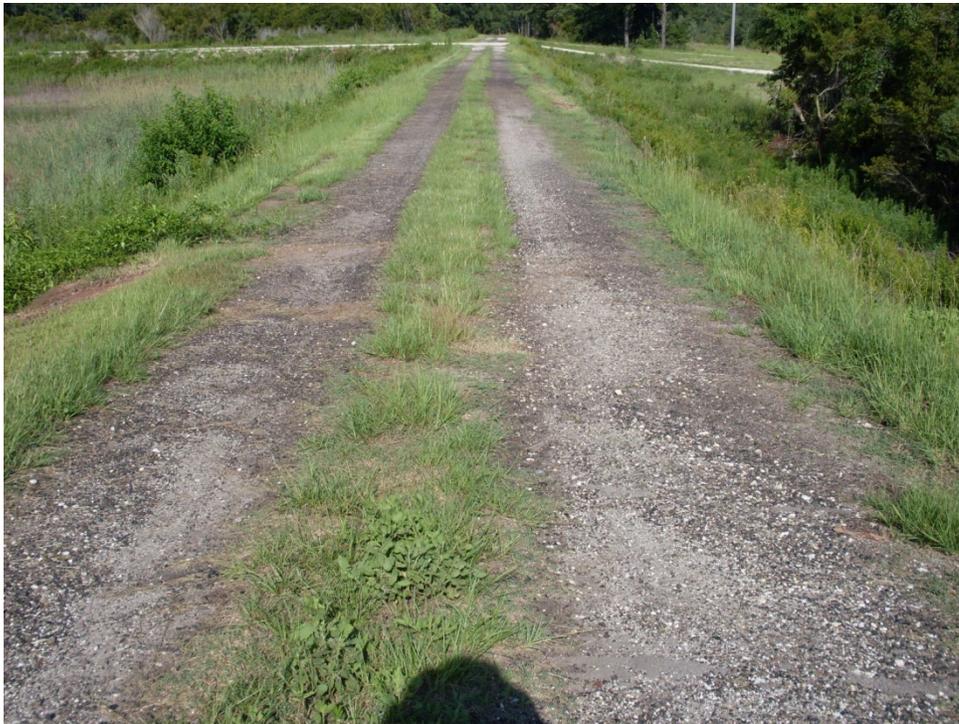
Photo B2-4: Crest of Perimeter Dike South Side of Unit 2 Slurry Pond West of Cross Dike – Viewed East.

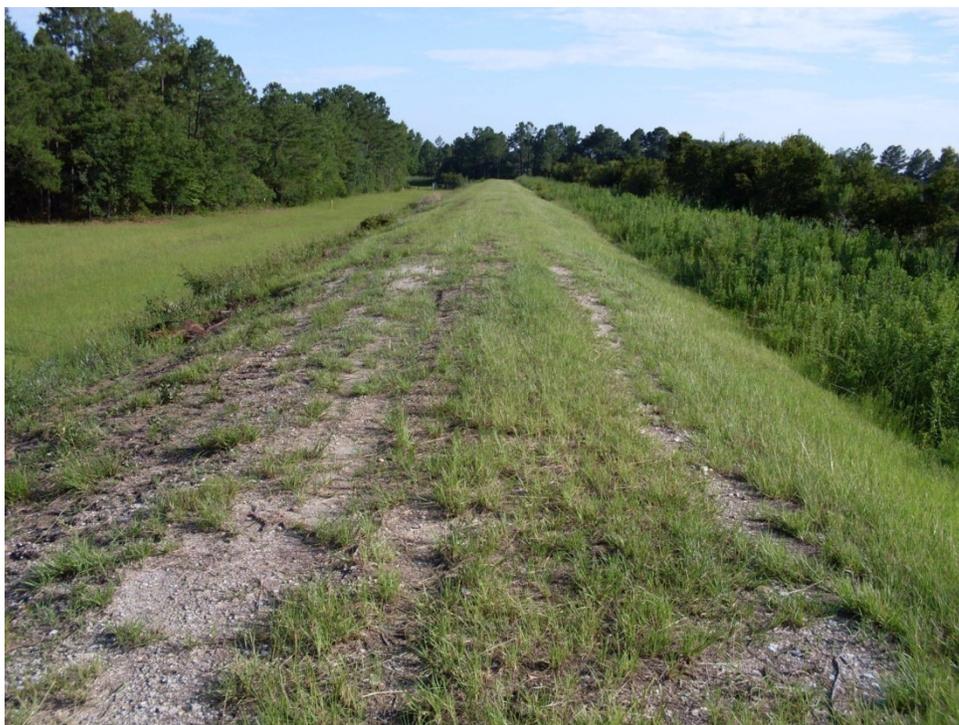
Photo B2-5: Crest of Perimeter Dike East Side of Unit 2 Slurry Pond– Viewed South (Note Sparse Grass Cover).

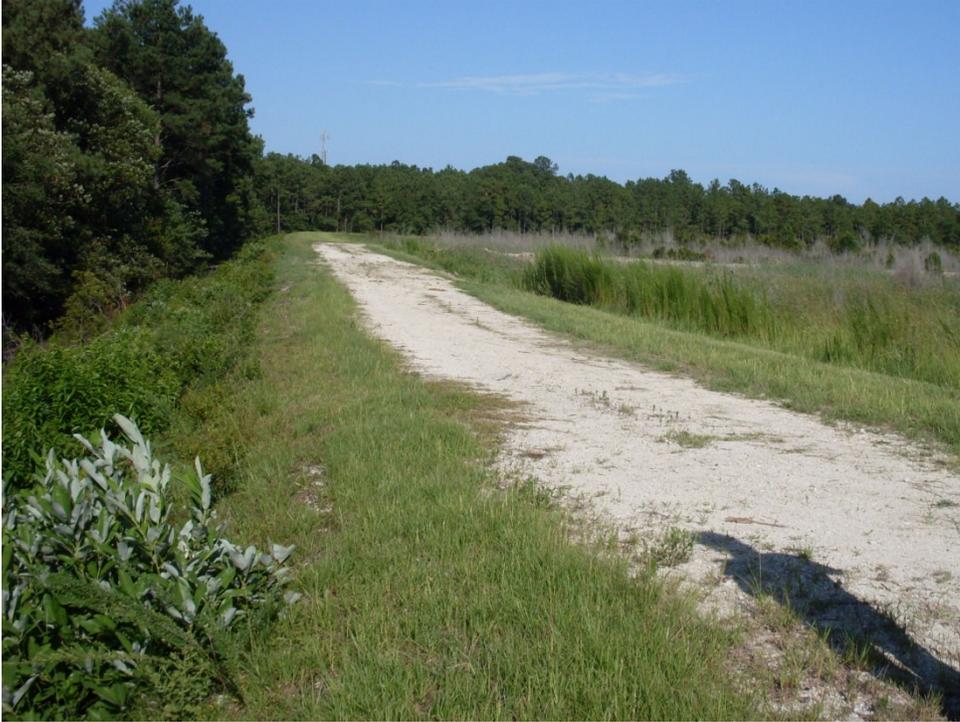
Photo B2-6: Crest of Perimeter Dike North Side of Unit 2 Slurry Pond West of Cross Dike – Viewed East.
